Arboricultural Assessment
(Tree survey)

On the site at

Glenamuck Road
Carrickmines
Dublin 18

March 2022

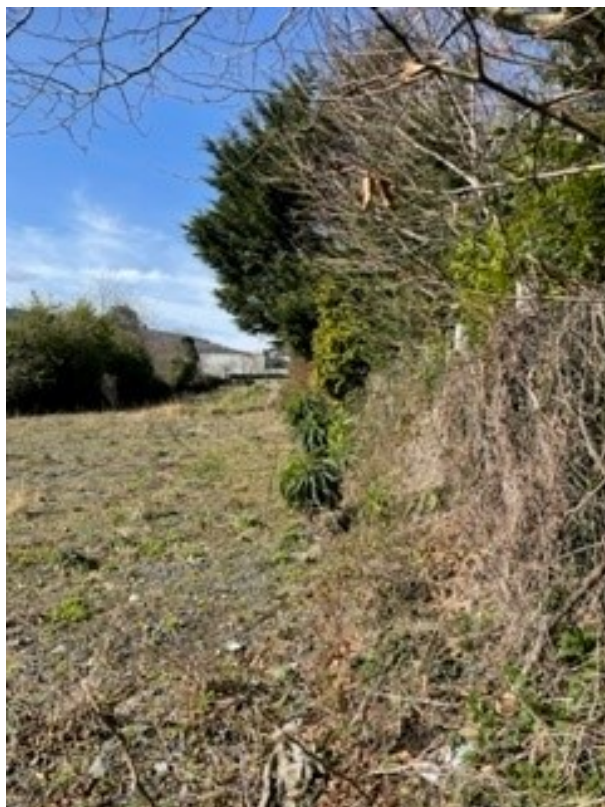
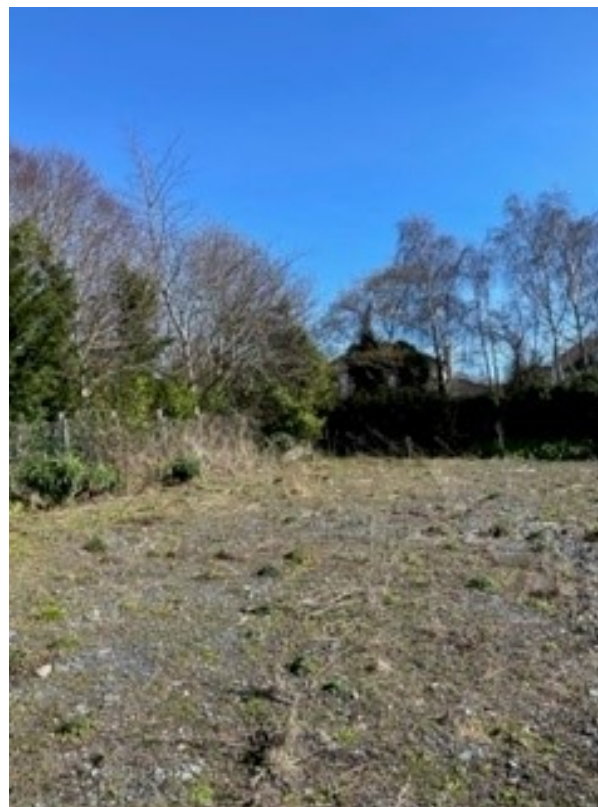
Boundary B looking east and west

This boundary is defined by a chain link fence, on the adjoining property are early mature trees; Copper beech, Norway maple x 2, Copper beech, Cypress, Oak, a beech hedge and a Sycamore. Within the garden are eight recently planted Leyland cypress.

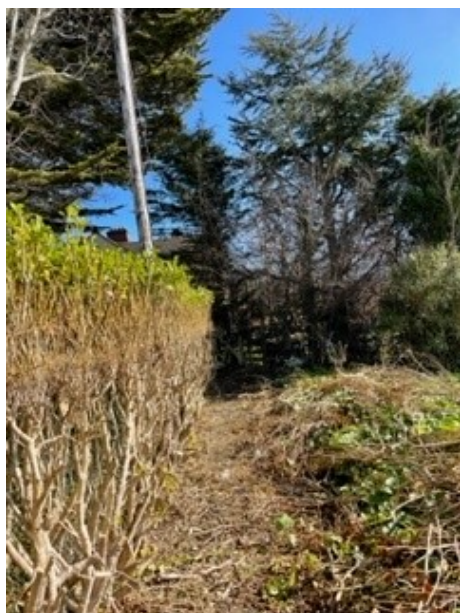
Boundary D, looking east at Boundary C.

This boundary has a chain link fence and Beech hedge, inside the hedge are nine Rowan, a Horse chestnut, a Beech and an Atlas cedar. There are also twelve recently planted Leyland cypress.

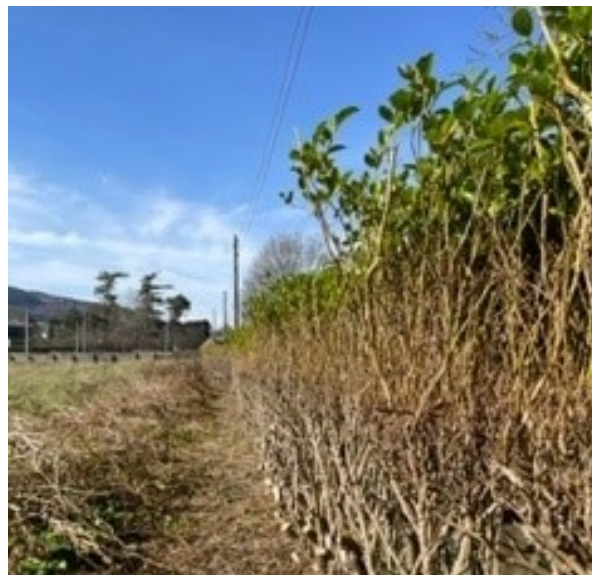
Boundary D looking west

Set back in the adjoining property is a mature Walnut, the boundary is defined by a mature Griselinia hedge on the neighbours property, which has been cut back and trimmed. At the western end set back on the opposite side of a drive way are three mature Sycamore.

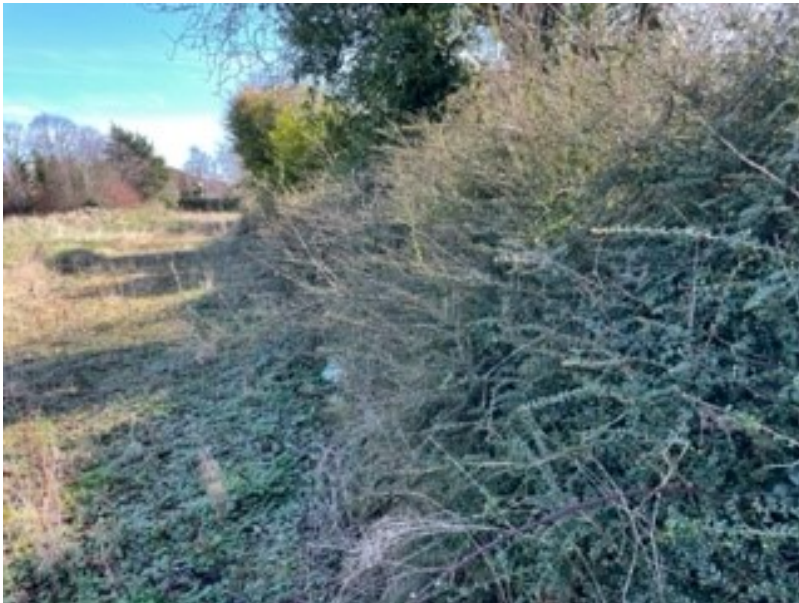
Boundary F, looking east.

This is the northern boundary of the property at Stafford Lodge, there are nature and early mature trees; an Ash infected with ash die back (*Hymenoscyphus fraxineus*) and in decline, an old Hawthorn with significant dieback. A red horse chestnut with dense ivy cover. There is a Lonicera hedge with Elder, Griselinia and Cherry-laurel. Near the house is an early mature Ash, at the eastern end are three cherry and a section of Cherry-laurel hedge.

Trees inside the adjoining property of boundary F are a Horse Chestnut and Sycamore and Blue cedar, they potential impacted by the footpath and the proposed new boundary wall. The recently planted trees will not be impacted by the proposals. Special measure will be taken to protect the trees, see part three Arboricultural Method statement.
